MSC-02680

# NATIONAL AERONAUTICS AND SPACE ADMINISTRATION

## APOLLO 13 MISSION REPORT

SEPTEMBER 1970

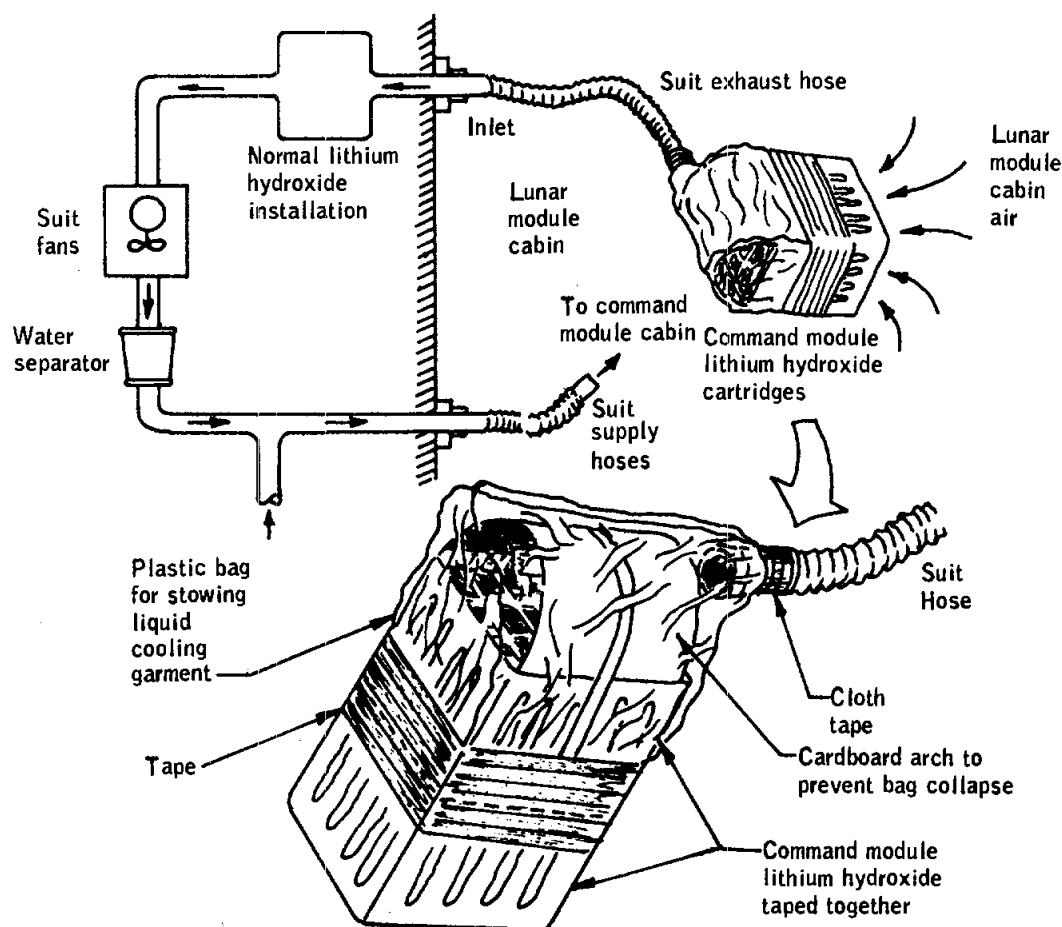
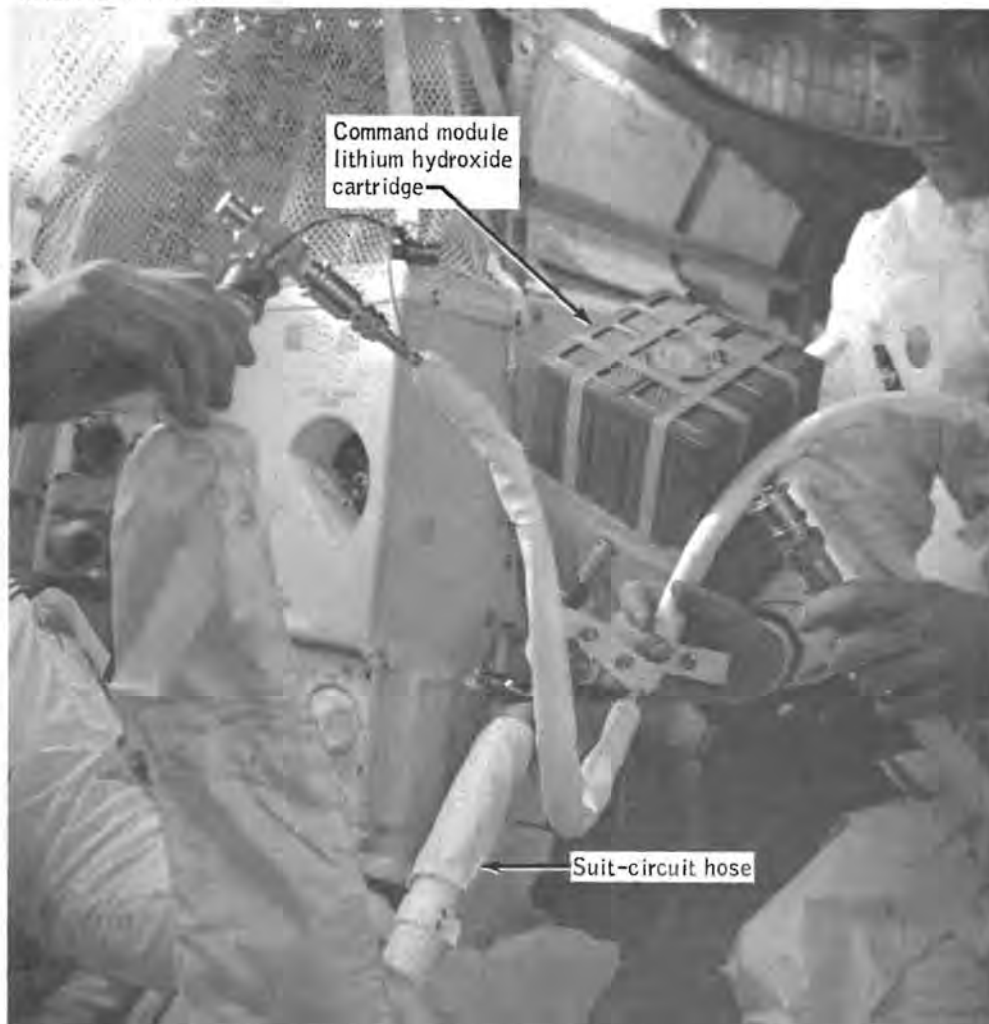
Figure 6.7-1.- Supplemental carbon dioxide removal system.

It became apparent that there were insufficient lithium hydroxide cartridges in the lunar module to support the abort mission, even with allowable carbon dioxide levels extended to a partial pressure of 15 mm Hg. With ground instructions, a system was constructed which attached a command module lithium hydroxide cartridge to each of two lunar module suit hoses. The Commander's remaining hose was placed in the tunnel area to provide fresh oxygen to the command module, while the Lunar Module Pilot's remaining hose was positioned in the lunar module environmental control area. At a later time, a second cartridge was added in series to the cartridges initially installed, as shown in figure 6.7-1. In each case, the drop in carbon dioxide levels reported by the ground showed satisfactory operation of this improvised carbon dioxide removal system.

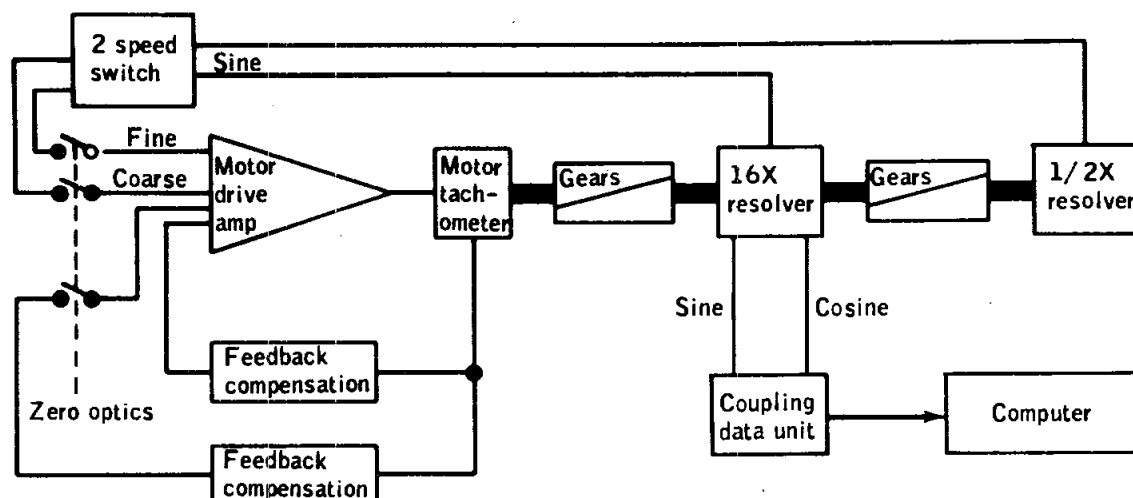
Figure 14-2.- Zero optics mode circuitry.

A simplified schematic of the optics shaft servo loop mechanization is shown in figure 14-2. In the zero optics mode, the sine outputs of

the half-speed and 16-speed resolvers are routed through a coarse/fine switching network to the motor drive amplifier and are used to null the system. Rate feedback from the motor tachometer is routed to the drive amplifier through a compensation network which removes any bias in the signal. When the zero optics mode is selected, the coupling-data-unit counter and the computer register which contains the shaft angle are zeroed for 15 seconds and then released to follow the 16-speed resolver. The half-speed resolver, the fine/coarse switching network, and the tachometer feedback compensation are used only in the zero optics mode.

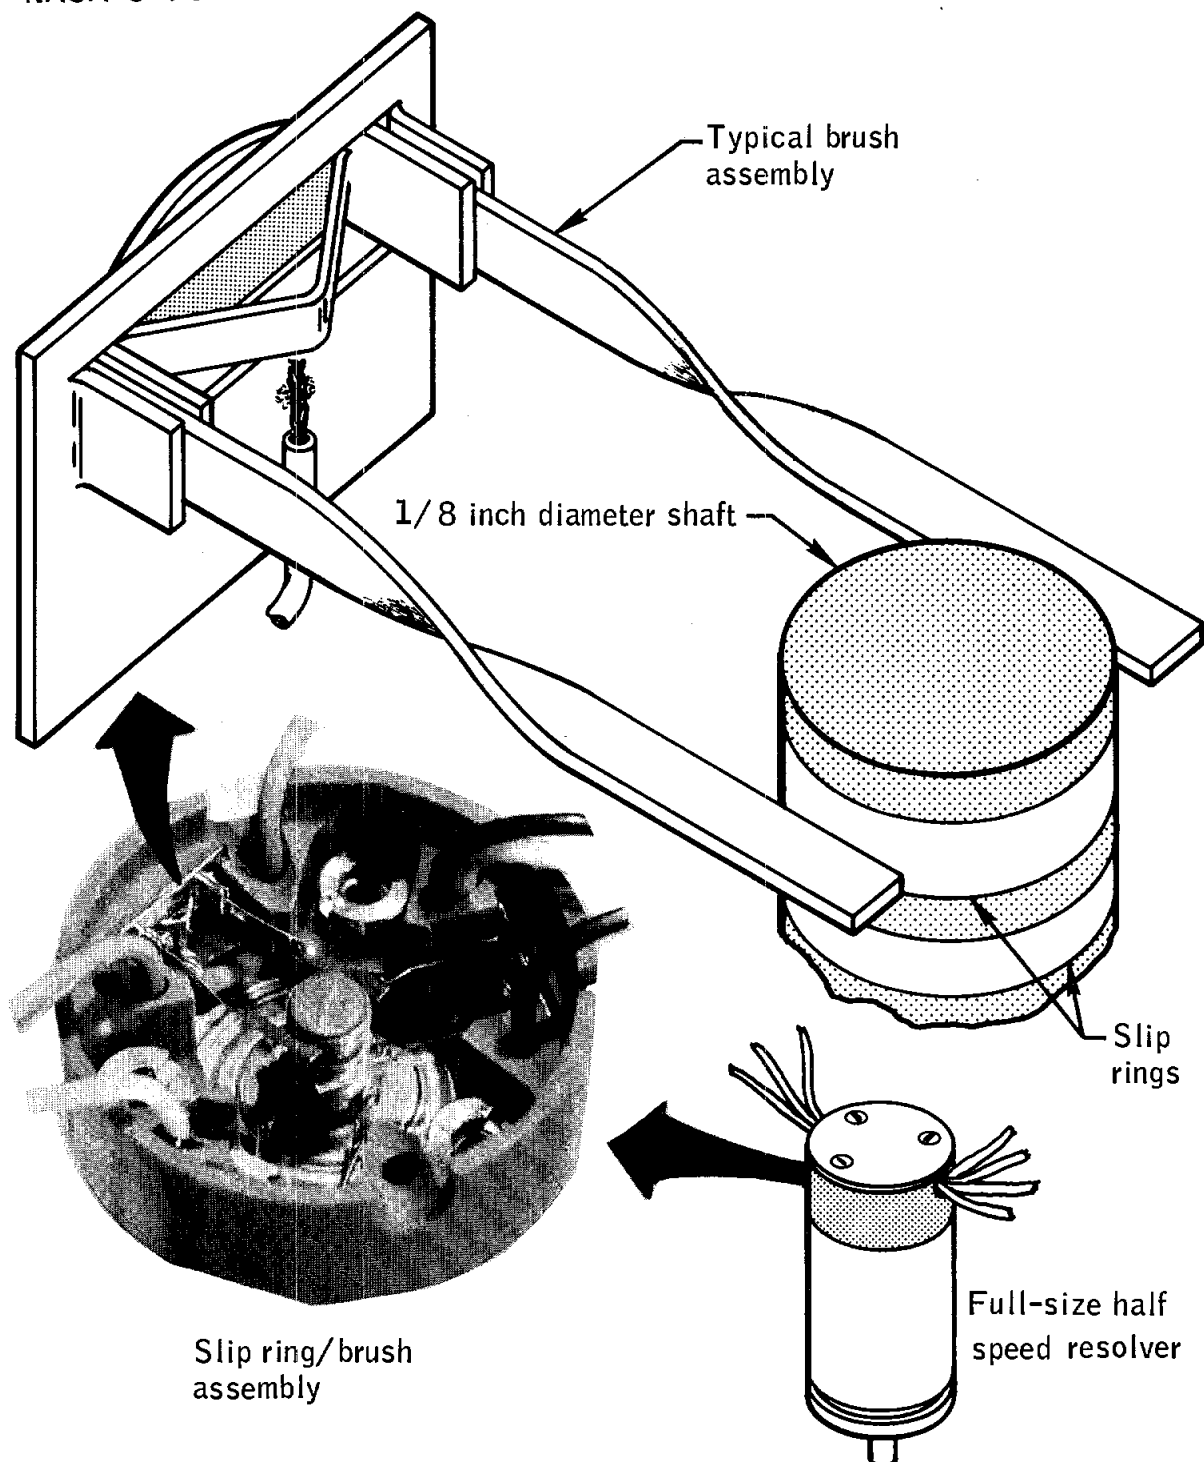
Figure 14-3.- Details of half speed resolver.

The most likely candidate is the half-speed resolver, which is used only for the shaft axis and only to provide an unambiguous zero reference. The reference voltage is applied to the rotor through slip rings (fig. 14-3), connected as shown in figure 14-4. If any resistance is present in the common ground path through the slip ring, a portion of the reference voltage will appear across the quadrature winding and induce a finite output (different than zero). Zero output is equivalent to zero degrees in shaft rotation.

Some evidence of susceptibility to vacuum was exhibited in this class of resolvers during qualification testing when variations of approximately 5 ohms were observed in the slip ring resistance during thermal

vacuum testing. The tests were run with the units rotating at 1 rpm, however, and the momentary resistance changes disappeared with the wiping action.

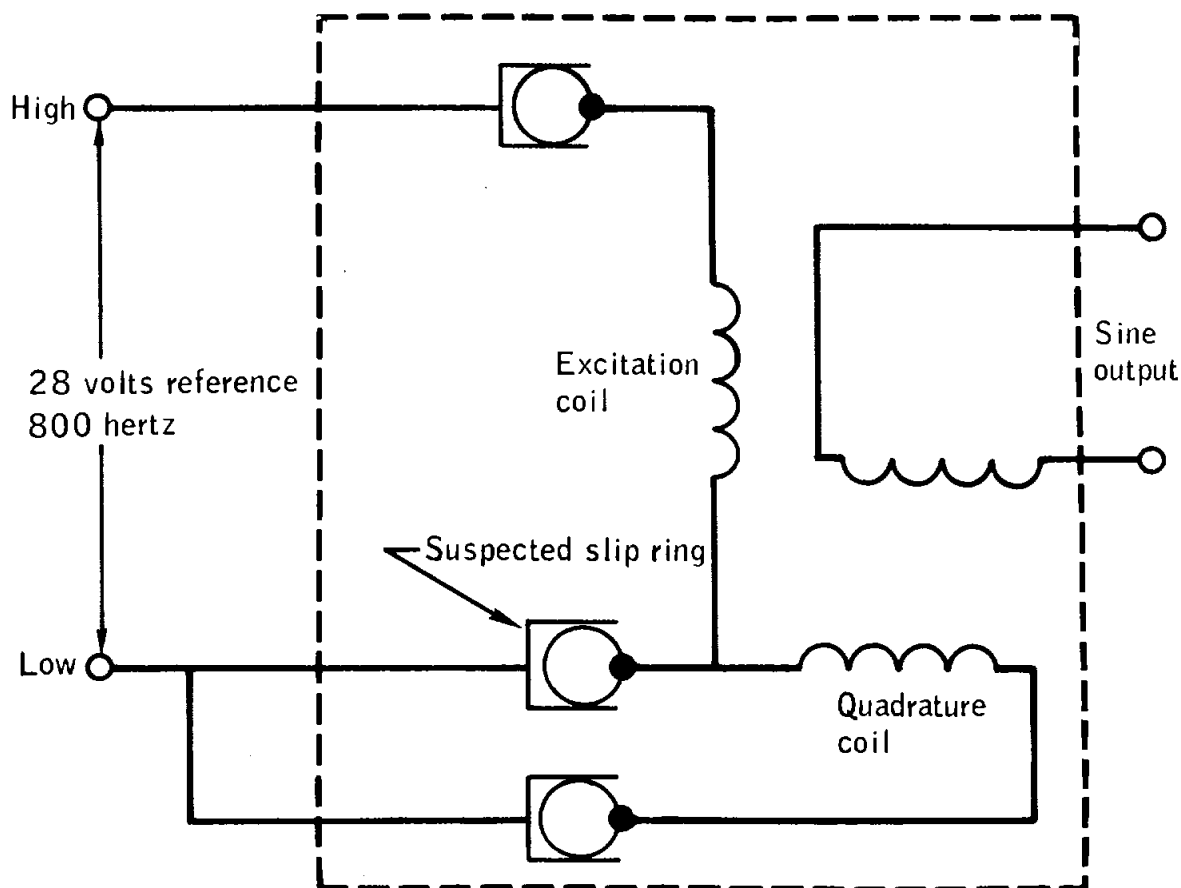
Figure 14-4.- One-half speed resolver.

Simulated changes in slip ring impedance were made on the half-speed resolver in the shaft loop (fig. 14-4). An impedance of 50 ohms produced an offset of approximately plus 0.5 degree in sextant shaft angle. The trunnion loop does not use this type of resolver or connection.

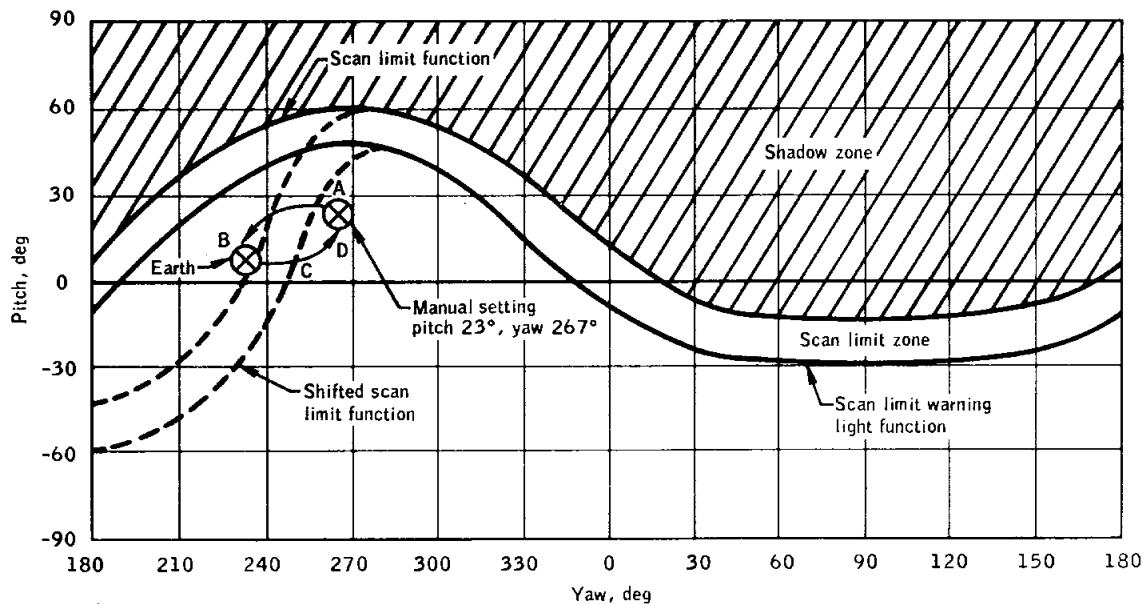
Figure 14-5.- Shift in scan-limit, scan-limit-warning illustrated.

Starting at 55:00:10 and continuing to 55:00:40, deep repetitive transients approximately every 5 seconds were noted on the phase modulated downlink carrier (fig. 14-5). This type of signature can be caused by a malfunction which would shift the scan-limit and scan-limit-warning function lines, as illustrated in figure 14-5. These function lines would have to shift such that they are both positioned between the antenna manual settings and the true line of sight to earth. Also, the antenna would have to be operating in the auto-reacquisition mode to provide these signatures. The antenna functions which caused the cyclic inflight RF signatures resulting from a shift in the function lines can be explained with the aid of figures 14-5 and 14-6, with the letters A, B, C, and D corresponding to events during the cycle. Starting at approximately 55:00:10, the antenna was switched from manual to auto reacquisition with the beamwidth switch in the medium-beam position. From point A to the scan limit function line just prior to point B, the antenna acquired the earth in wide beam. When the antenna reached the scan limit function line, the antenna control logic would switch the system to the manual

mode and drive back toward the manual settings until the scan limit warning function line at point C was reached, thereby maintaining wide-beam operation. When the antenna reaches the scan limit warning function line, the system would automatically switch to the medium-beam mode and continue to drive in the manual mode until the manual setting error was nulled out at point A. The antenna would then switch to the auto-track mode and repeat the cycle. The most important feature of this cycle is that the antenna moves at the manual scan rate between points B and D, which is confirmed by the rapid changes in the downlink signal strength.

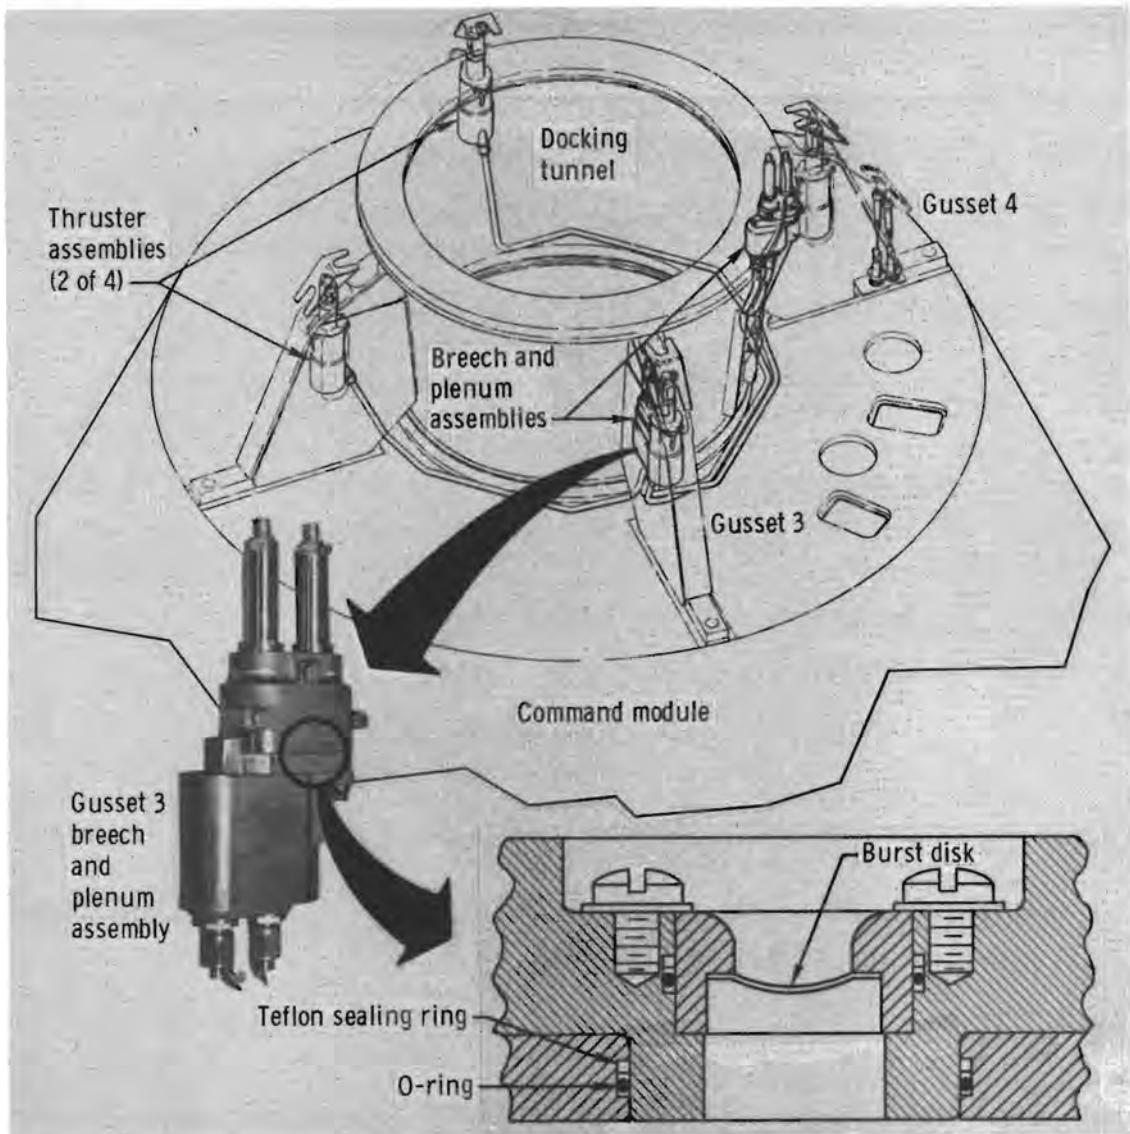
Figure 14-7.- Apex cover jettison system.

During postflight inspection, it was discovered that propellant gas had leaked from the gusset-4 breech assembly, which is a part of the apex cover jettison system (fig. 14-7). A hole was burned through the aluminum gusset cover plate (fig. 14-8), and the fiberglass pilot parachute mortar cover on the parachute side of the gusset was charred but not penetrated. The leakage occurred at the breech-plenum interface (fig. 14-9). The breech and plenum are bolted male and female parts which are sealed with a large O-ring backed up with a Teflon ring, as shown in figure 14-7. During operation, the breech pressure reaches approximately 14 000 psi and the gas temperature exceeds 2000° F. The O-ring and backup ring were burned through and the metal parts were eroded by the hot gas at the leak path. The system is completely redundant in that either thruster system will effect apex cover jettison. No evidence of gas leakage existed on the previous firings of 56 units.

The possible causes of the gas leakage include:

- a. Out of tolerance parts - Measurement of the failed parts indicate acceptable dimensions of the metal parts.
- b. Damaged O-rings - The 21 000-psi static proof-pressure test was successful.
- c. Gap in backup ring - The installation procedure specifies the backup ring may be trimmed on assembly to meet installation requirements,

but does not specify any dimensional control over the scarf joint. Since the gap portion was burned away, a gap in the backup ring could have caused the problem.

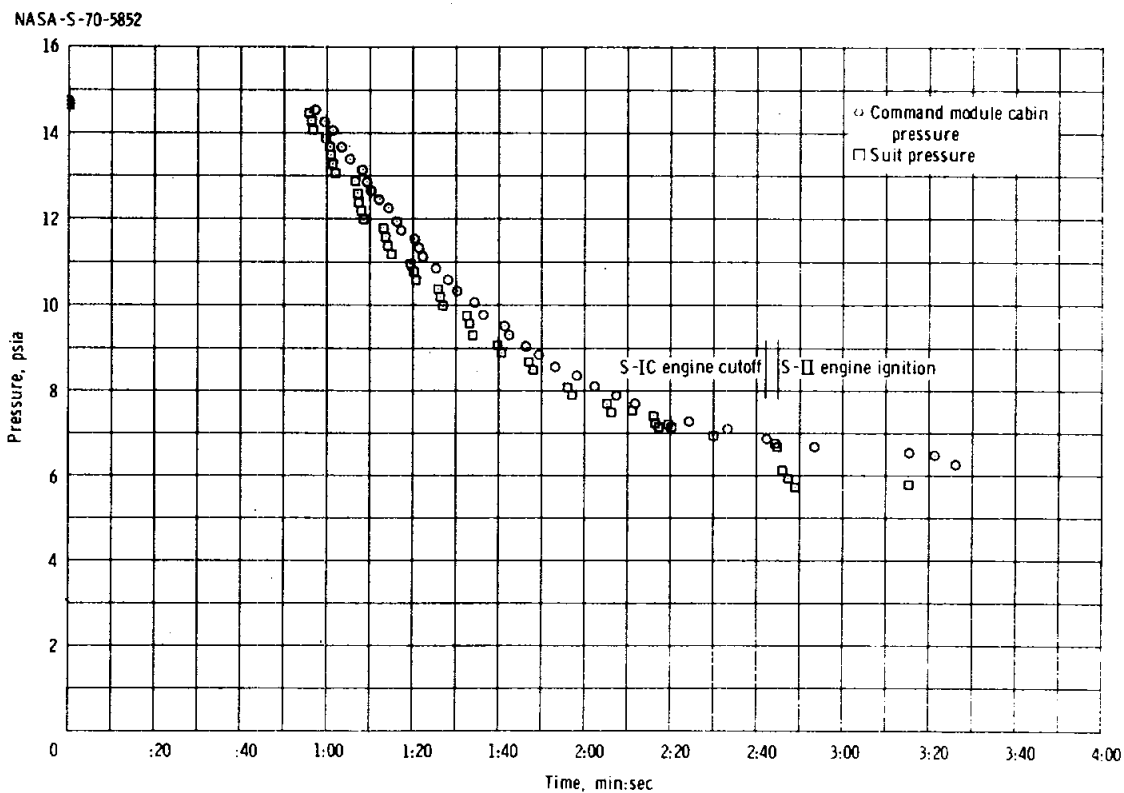
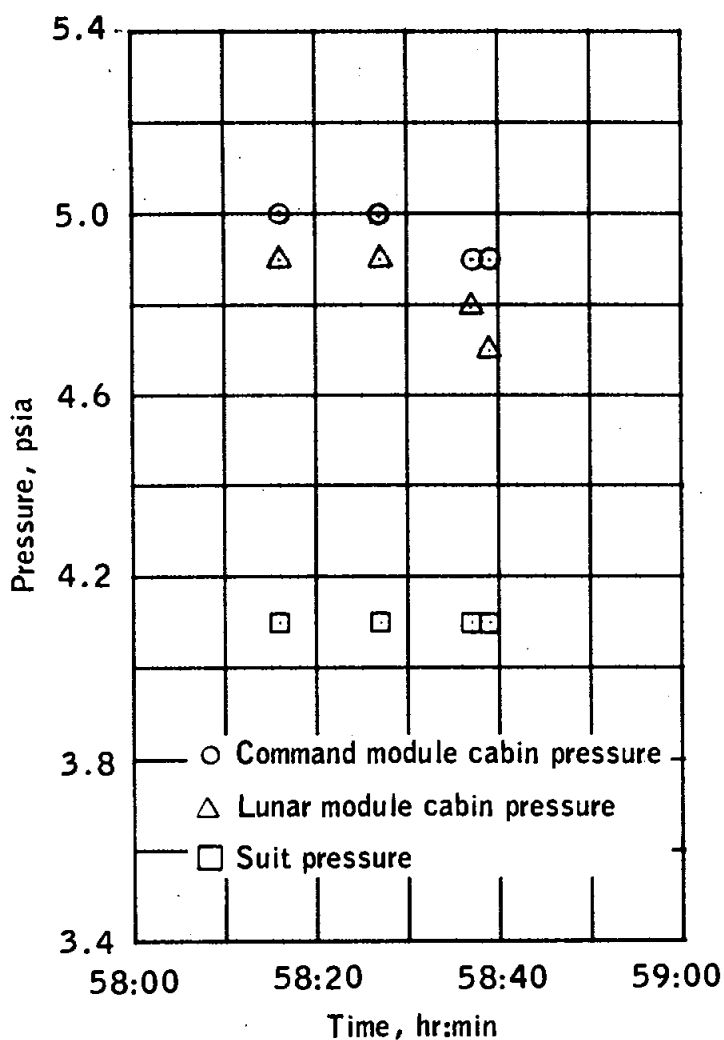
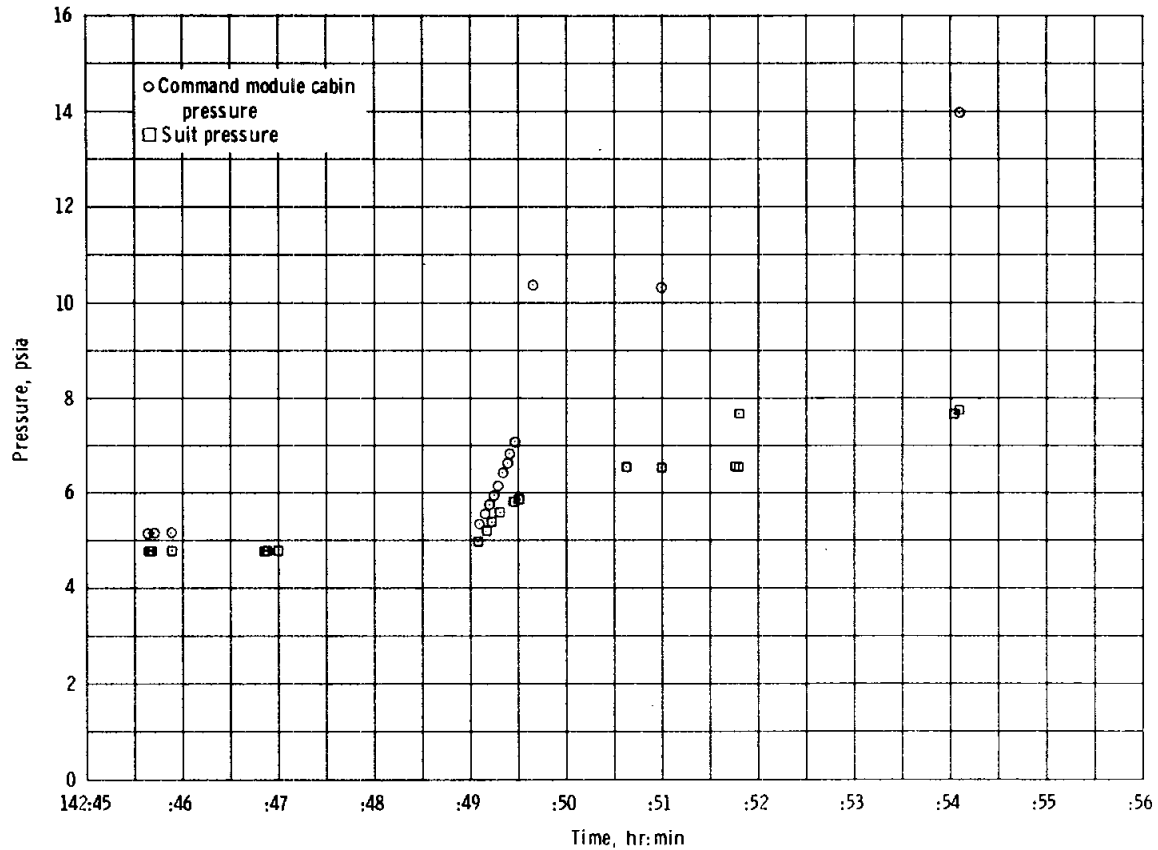
Figure 14-12.- Suit and cabin pressure.

During launch the suit pressure transducer reading remained consistent with cabin pressure until 00:02:45, then suddenly dropped from 6.7 to 5.7 psia coincidentally with S-II engine ignition (fig. 14-12). The difference between the two measurements decreased to only 0.2 by 1-1/2 hours, when the cabin reached its nominal regulated pressure of 5.0 psia. For this shirtsleeve mode, the suit and cabin pressure readings should be nearly equal. During normal variations in the command module cabin pressure, the suit pressure measurement responded sluggishly and indicated as much as 1 psi low. Subsequently, the measurement output decayed and remained in the 4.1 to 4.3 psia range for a cabin pressure of 5.0 psia until system deactivation at about 59 hours (fig. 14-12).

During periods when the lunar module and the command module cabins were interconnected, the lunar module and command module cabin pressure readings were approximately equal, verifying the operation of the command module cabin pressure transducers.

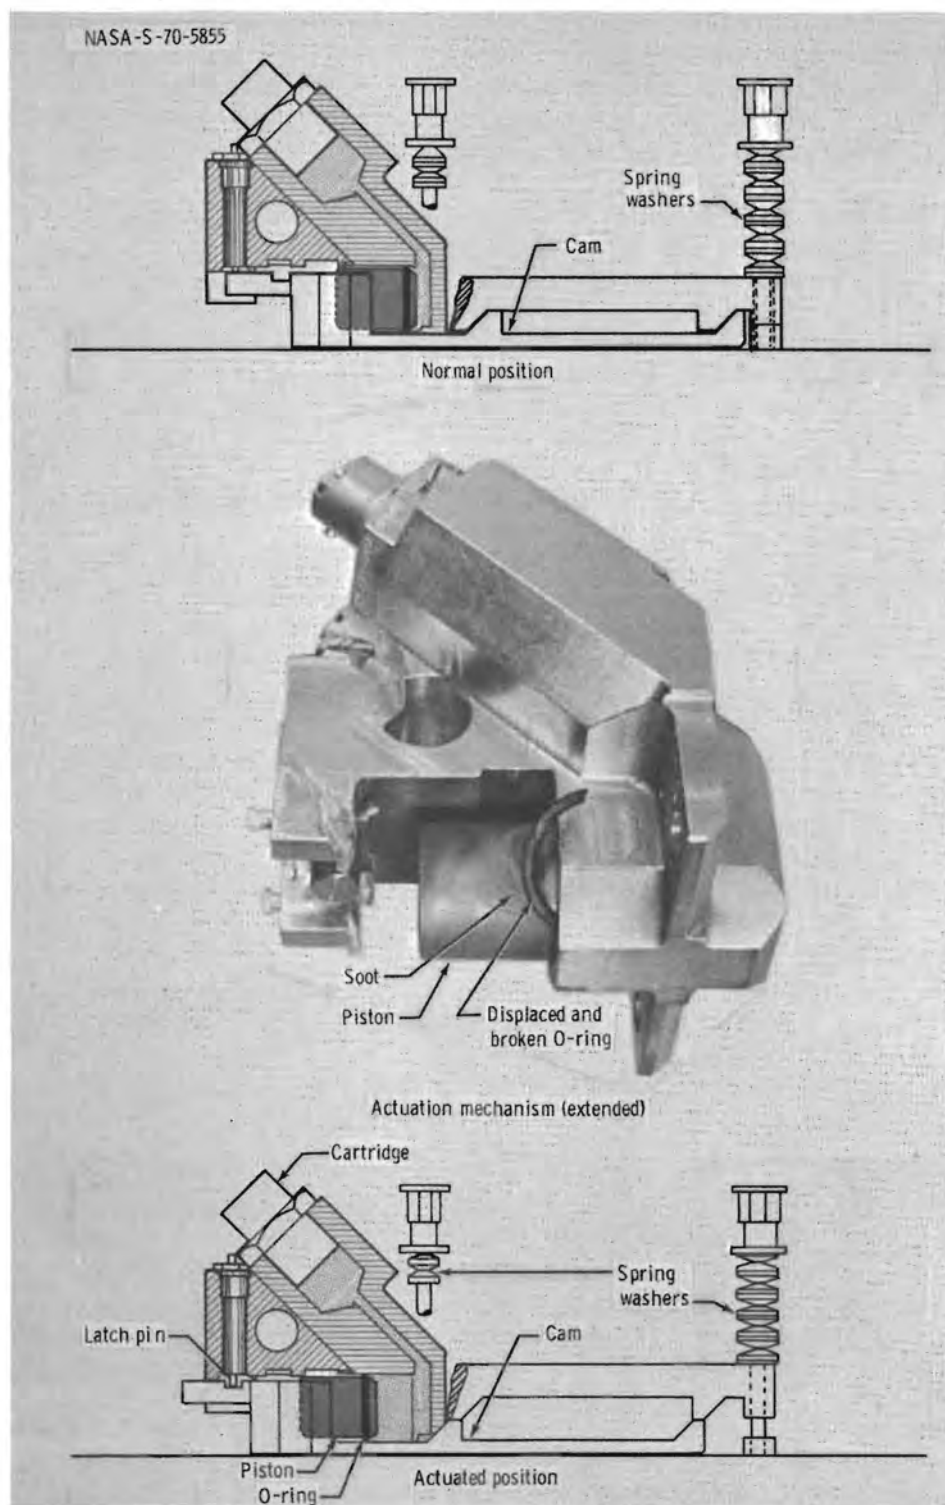
Figure 14-13.- Circuit interrupter.

During postflight inspection of the command module, propellant gas was noted to have escaped from the left-hand electrical circuit interrupter, mounted in the lower equipment bay, and deposited soot on adjacent equipment. The right-hand circuit interrupter showed no evidence of a gas leakage. The removed breech, showing the displaced O-ring and crushed attenuator block, is shown in figure 14-13.

The two interrupters open the electrical circuits about 30 milliseconds before the wires are severed by the command module/service module umbilical guillotine. As illustrated in the figure, a cam fork is moved by a piston, which is operated by propellant gas from redundant cartridges, to function a lift plate. Motion of this plate disconnects the male and female portions of electrical connectors located, respectively, in the lift plate and in the base plate of the interrupter. At the completion of the stroke, the fork is brought to rest by impacting and crushing an aluminum block mounted on the interrupter housing.

The worse-case tolerance buildup is when the fork contacts the attenuator block and the piston O-ring is 0.075 inch from entering the chamfer in the breech assembly. The O-ring enters this chamfer when the block has been crushed about 94 percent, at which point an O-ring displacement and accompanying gas escape could be expected. The factors which affect the degree of attenuator crushing are generally uncontrollable within narrow limits and include:

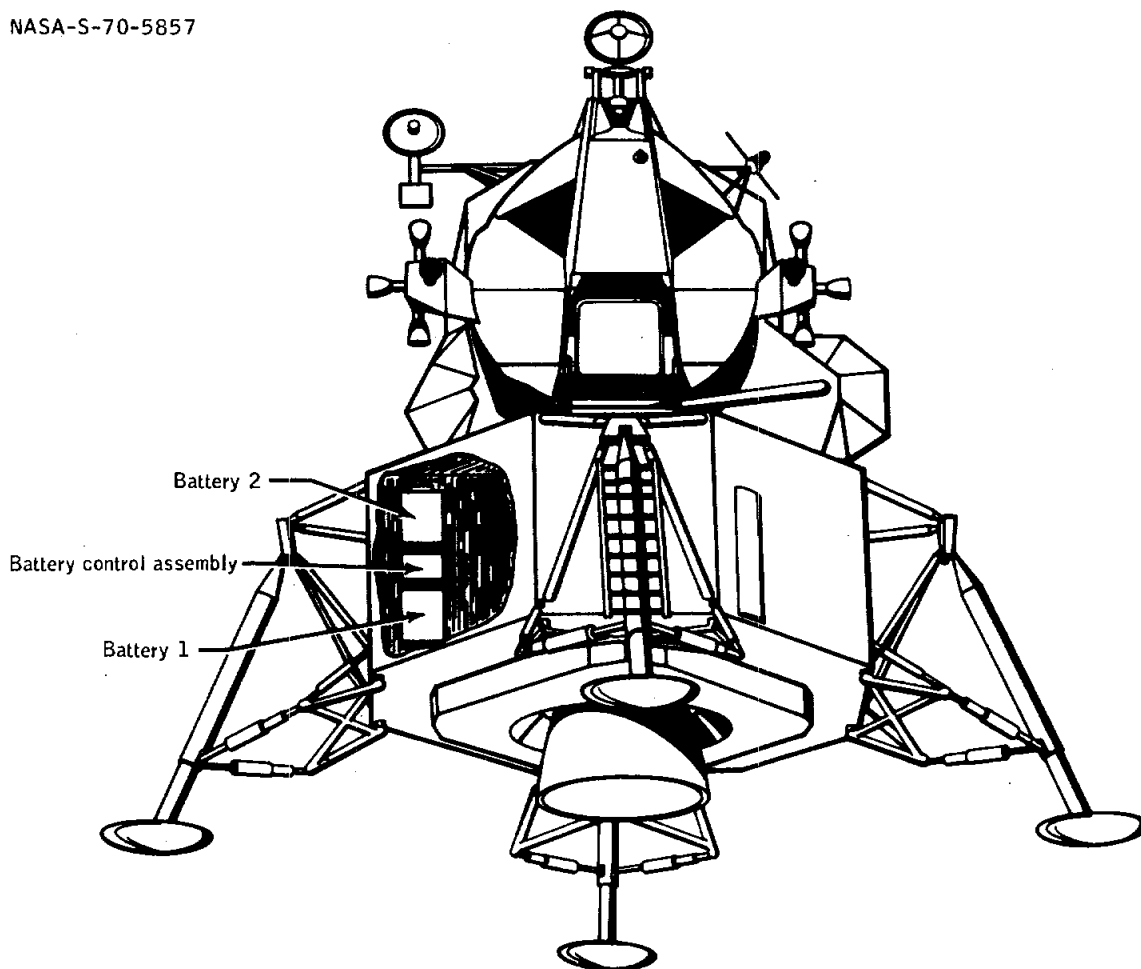
Figure 14-15.- Descent stage battery location.

At 97 hours 14 minutes, the crew reported a thumping noise and snowflakes venting from quadrant 4 of the lunar module descent stage (fig. 14-15). All four descent batteries experienced current transients at 97:13:53 for about 2 seconds, with corresponding drops in dc bus voltage (fig. 14-16). Also, the water glycol pressure differential for the heat transport system decreased momentarily, indicating that the glycol pump momentarily slowed down.

The thumping noise occurred at about the same time as the current spikes. The current spikes show that a momentary short circuit existed in the Lunar-Module-Pilot side of the dc electrical system, which includes descent batteries 1 and 2 (fig. 14-16). The current surge was not of sufficient duration either to open the balance-load cross-tie circuit breakers, to display a reverse current indication, or to trip a battery-off relay as a result of an overcurrent condition.

Evidence indicates that battery 2 may have experienced an electrical fault of some type. The most probable condition is electrolyte leaking from one or more cells and bridging the high-voltage or low-voltage terminal to the battery case (fig. 14-17). This bridging results in water electrolysis and subsequent ignition of the hydrogen and oxygen so generated. The accompanying "explosion" would then blow off or rupture the seal of the battery lid and cause both a thump and venting of the free liquids in the battery case, resulting in "snowflakes."

- a. Electrolyte can leak past the Teflon retention screens installed in each cell to prevent leakage.
- b. The descent battery cells contain an excessive amount of free electrolyte.
- c. The potting does not adhere to the battery case, consequently, any free electrolyte can readily penetrate the interface between the potting and the case and bridge between the terminals and case.
- d. Once an electrolyte bridge is formed, electrolysis will produce hydrogen and oxygen gas.
- e. A bridge at the positive terminal can produce a current surge of as much as 150 amperes.

For Apollo 14 and subsequent missions, the descent batteries will be modified to minimize the hazards associated with electrolyte leakage.

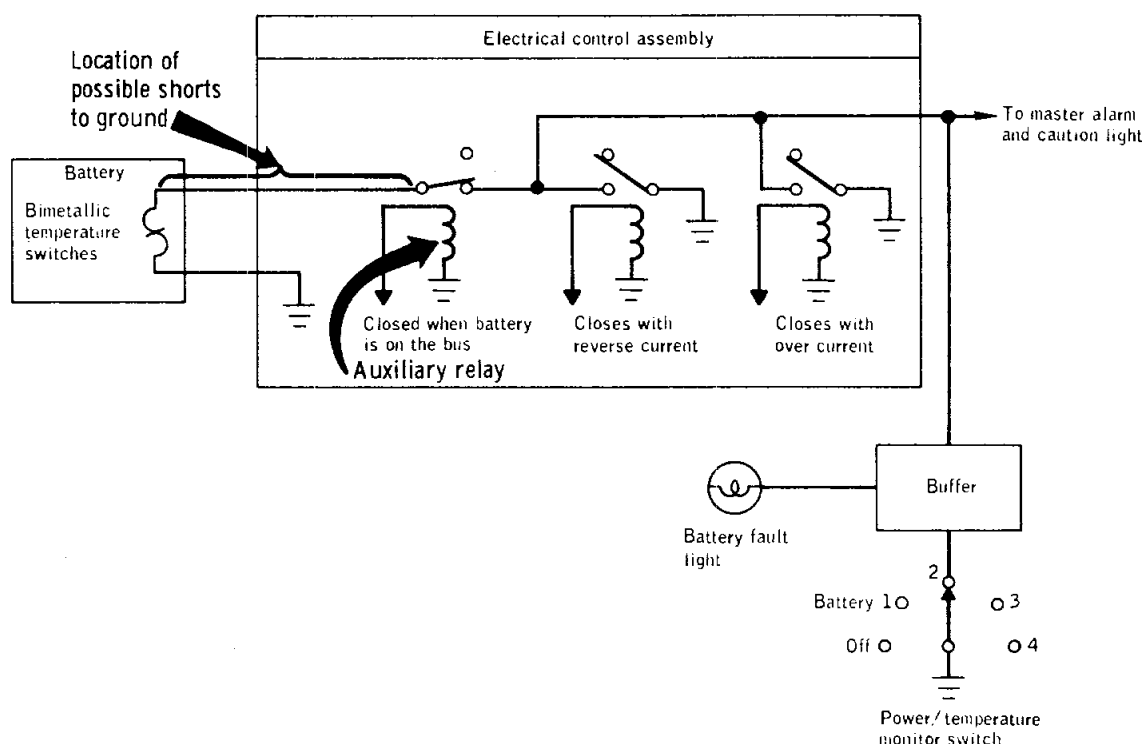
Figure 14-18.- Battery 2 malfunction circuit.

The battery malfunction light illuminated at about 100 hours with a corresponding master alarm. The malfunction, isolated to battery 2, could have been caused by an overcurrent, a reverse-current condition, an over-temperature condition, or possibly an erroneous indication. The logic for these malfunction conditions is shown in figure 14-18.

A battery overcurrent can be ruled out because automatic removal of the battery from the bus would have occurred.

A reverse-current condition can be ruled out because, if the battery is removed from and reapplied to the bus, the reverse-current circuit has a built-in delay of about 5 seconds before the reverse-current relay is again activated to illuminate the light. Battery power was removed from and replaced on the bus in flight, and the light immediately illuminated again when the battery was reconnected.

An over-temperature condition can be ruled out because, after the battery was replaced on the bus, the light remained illuminated for a brief period and then began flickering intermittently. A flickering light cannot be caused by the temperature sensing switch because of a temperature hysteresis of approximately 20° F in the switch. The water glycol loop temperature also indicated that the battery temperature was normal.

Either a short between the temperature switch wires to ground or a contamination in the auxiliary relay would actuate the light. The shorted condition could have resulted from electrolyte shorting within the battery case associated with the current surges discussed in the previous section. Contamination of the auxiliary relay has occurred in the past, and relays already packaged were not retrofitted since a false over-temperature indication can be identified as it was here.

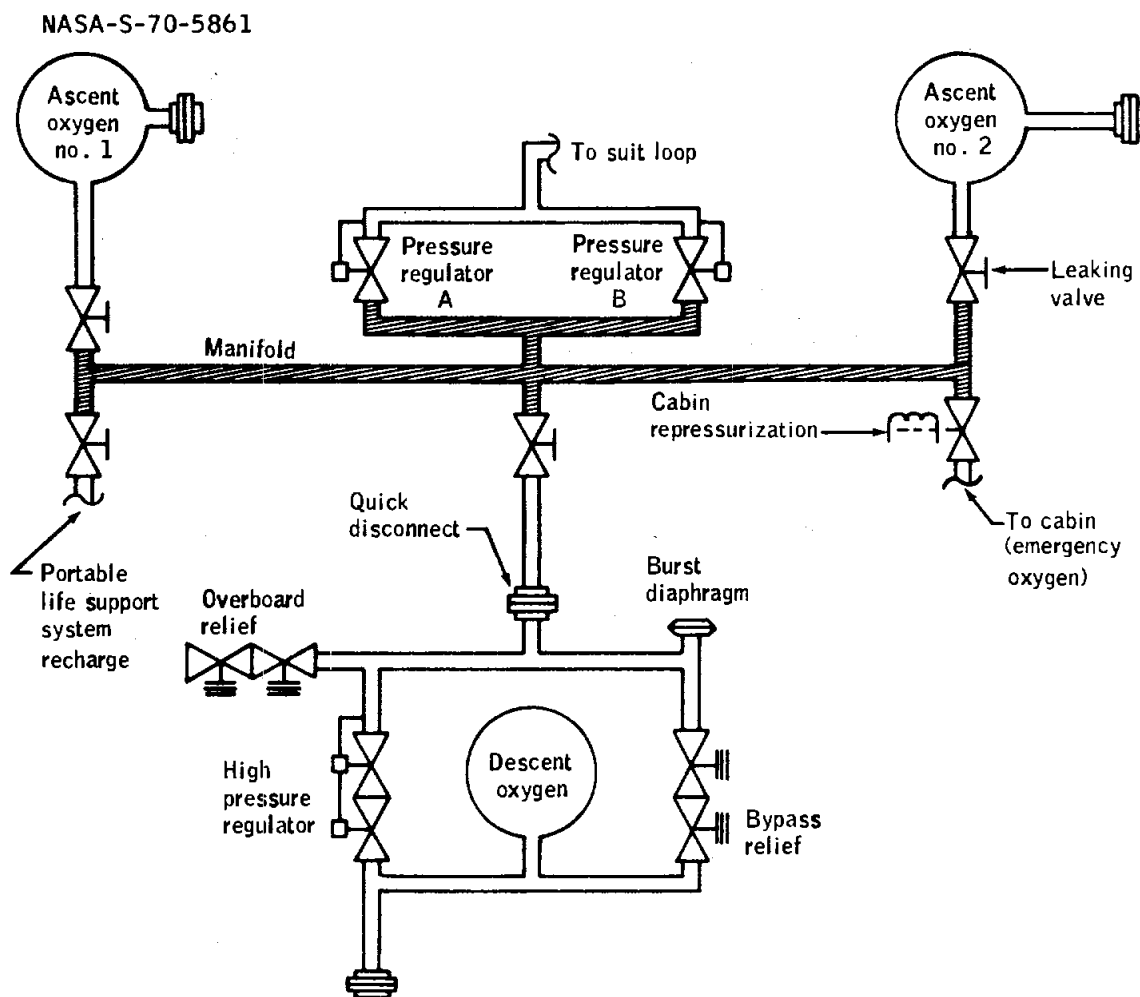
Figure 14-19.- Oxygen-supply system.

During the flight, the pressure in the ascent stage oxygen tank 2 increased, indicating a reverse leakage through the shutoff valve from the oxygen manifold (fig. 14-19) into the tank. The leak rate, with a maximum differential pressure of 193 psi, varied from about 0.22 lb/hr (70 000 scc/hr) to zero when the tank pressure reached manifold pressure. Allowable leakage for the valve in either direction is 360 scc/hr. Pre-flight test data indicate a reverse leakage of 360 scc/hr and no excessive leaking in the forward direction.

The internal portion of three valves of this type had been replaced previously on the spacecraft because of excessive leakage through the ascent oxygen tank 1 shutoff valve. In one valve, a rolled O-ring

(fig. 14-20) caused the leakage. When the valve is installed, the forward O-ring can be rolled and damaged when it passes the manifold port. In the other two valves, the cause was not identified and was assumed to be contamination.

The production tolerances of the valve and bore were examined to determine if a tolerance buildup problem existed. The manufacturer's specification to which the valve was designed requires that the O-ring be subjected to a compression of between 0.0115 and 0.0225 inch, whereas the O-ring supplier recommends between 0.011 and 0.017 inch. The added

Leak tests previously performed on the valve were inadequate, in that only reverse leakage at high pressure was determined. For future vehicles, forward and reverse leakage at both high and low pressures will be measured to detect any defective valves.
